# REPORT ON 'MAPPING THE OLD WITH THE NEW: RE-IMAGING THE 1727 ZEEWIJK SHIPWRECK SITE WITH NEW RECORDING TECHNOLOGY' PROJECT

(Grant Number: GCE-2019-03)

**Report—Western Australian Museum, Department of Maritime Archaeology, No. 339**

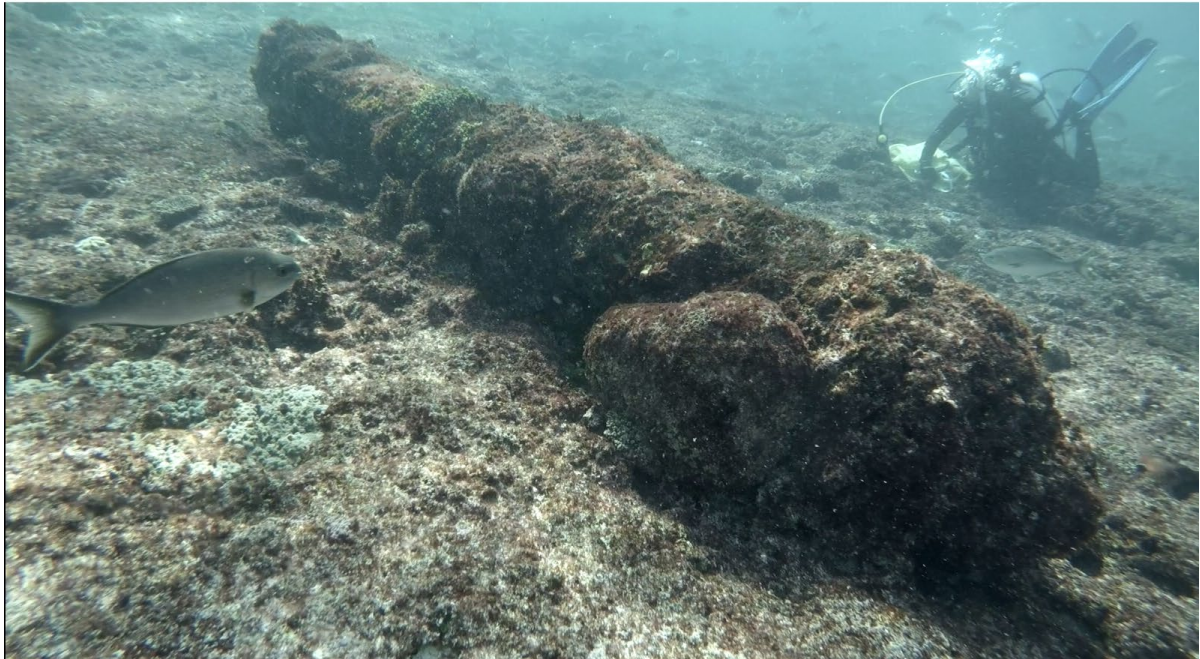
Fig. 8. Wendy van Duivenvoorde recording 12-pounder cannon, Magnetic Anomaly ZW002 of the 2016 aerial magnetometer survey in 2019 (D. Shefi, WA Museum, 2019).

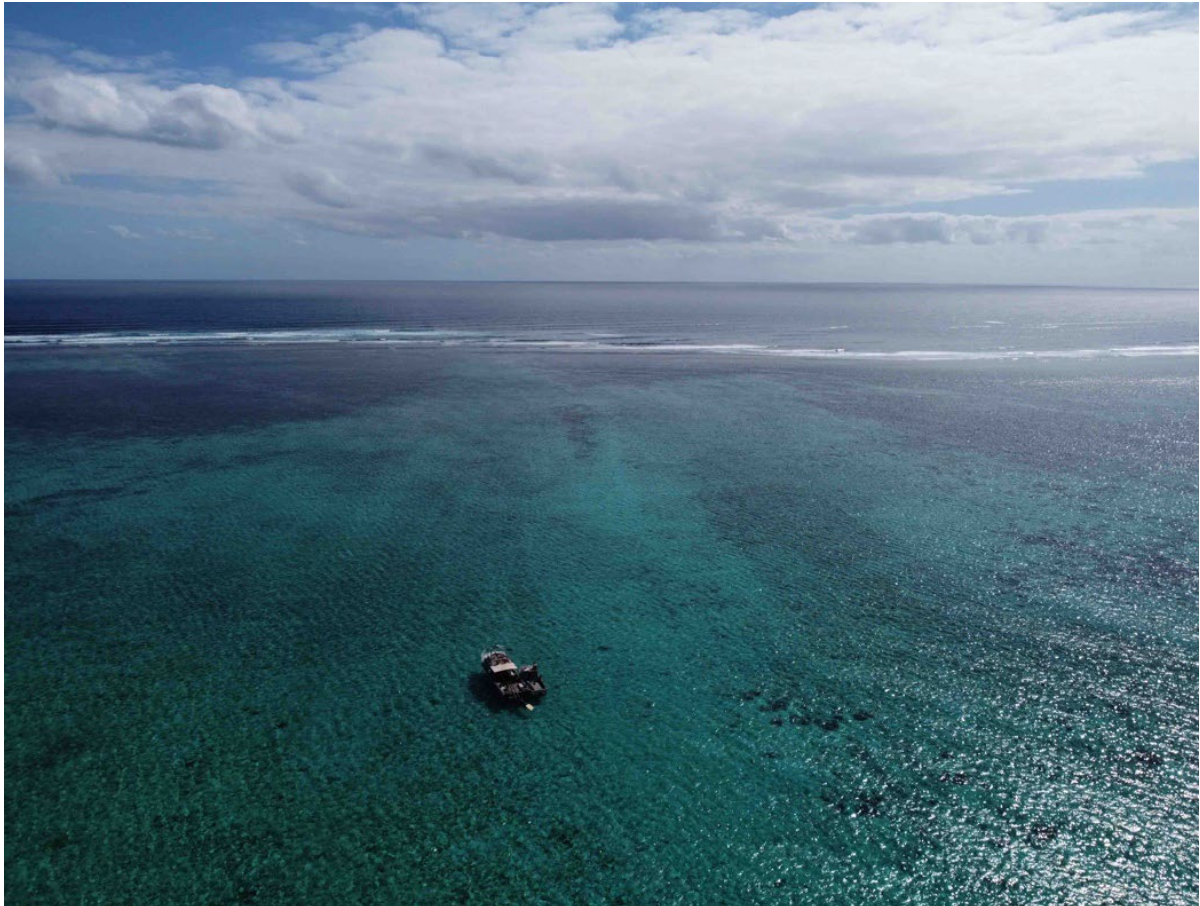
Fig. 9. Site overview looking west with vessels moored inside the lagoon (the inner site), the outer reef site is in the surf in the centre of image, directly west of the boats (K. Edwards, WA Museum, 2022).

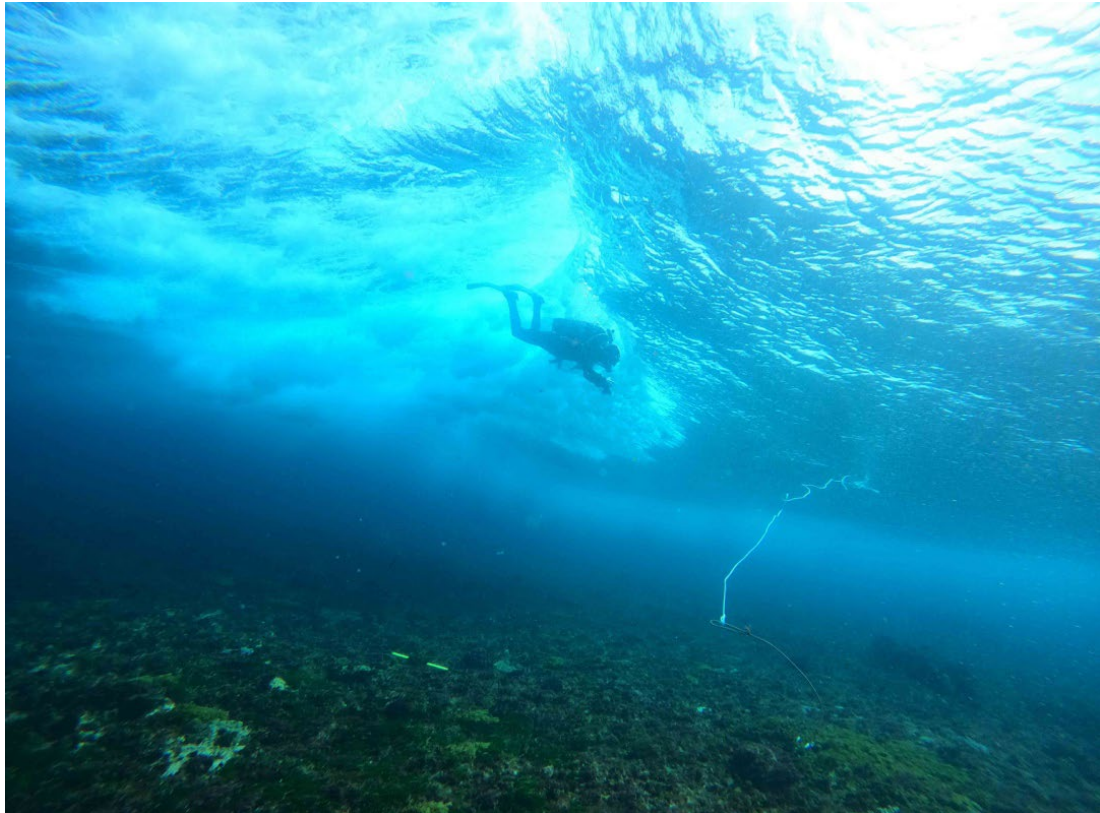
Fig. 14. Patrick Morrison undertaking 3D photogrammetry survey in the 8-cannon area as a wave passes overhead (R. Anderson, WA Museum, 2022).

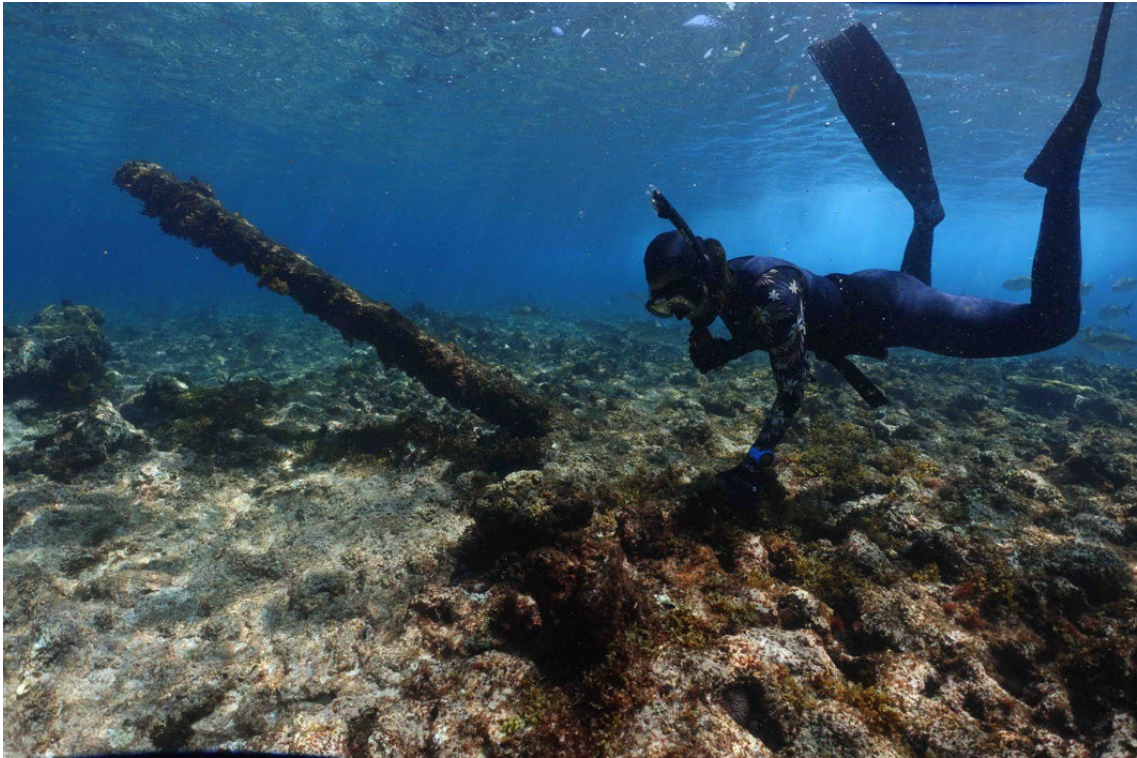
Fig. 23. Deb Shefi inspecting the anchor shank and palm in the gutter area (R. Anderson, WA Museum, 2022).

All other disassociated anchor parts previously mapped in the 1970s such as the broken arm, palm and crown were relocated in 2022. A previously unidentified palm was identified concreted into the reef associated with the protruding anchor shank in the gutter. Furthermore, the 'tangled anchor' east of the 12-cannon area is marked on one WA Museum site plan as 'anchors', though on another as just one 'anchor'. The 2022 survey confirmed it to be a single anchor, with some unidentified ironwork and ballast stones trapped/concreted around it.

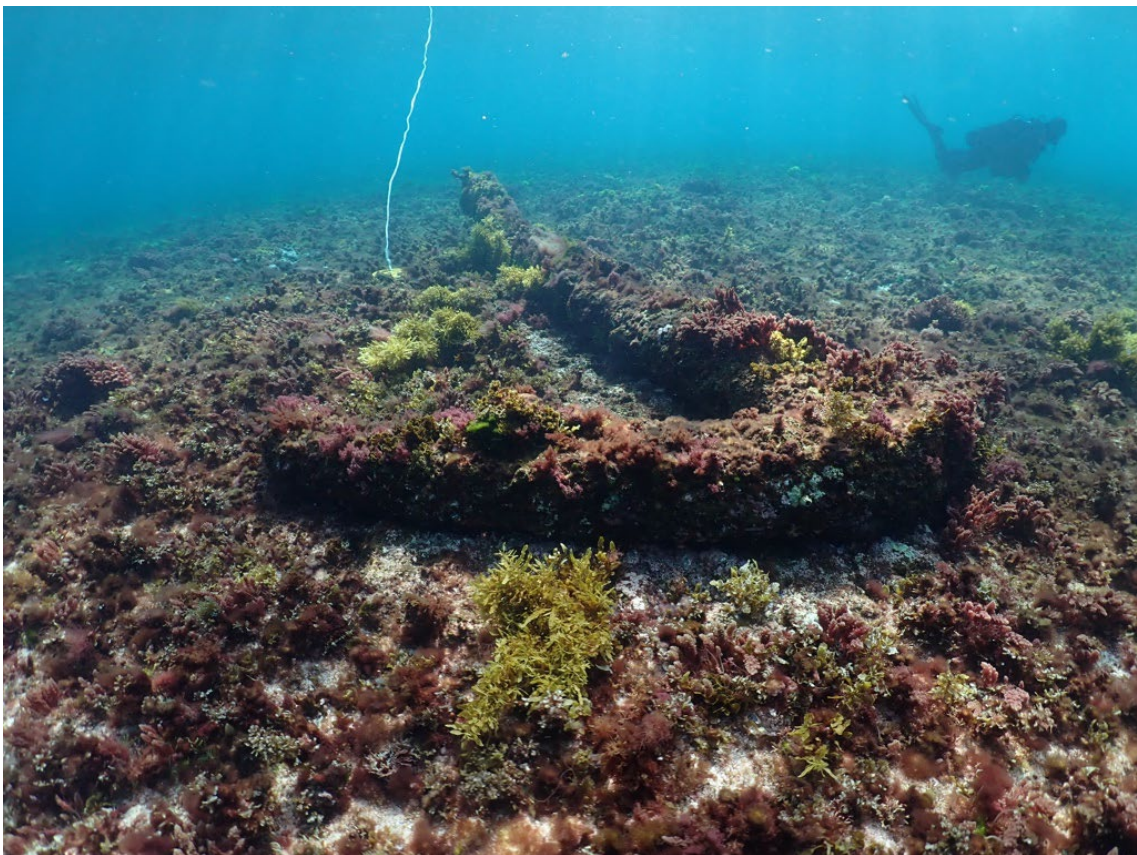
Fig. 24. One-armed anchor (D. Shefi, WA Museum, 2022).

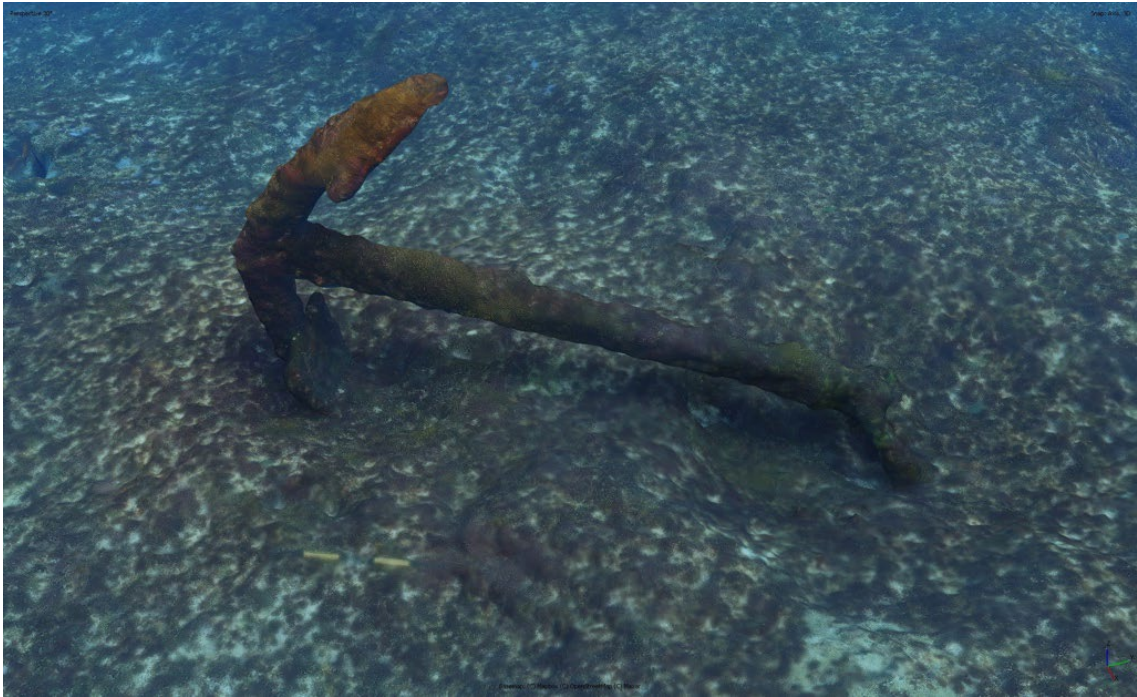
Fig. 25. 3D model of main standing anchor (P. Morrison, WA Museum, 2022).

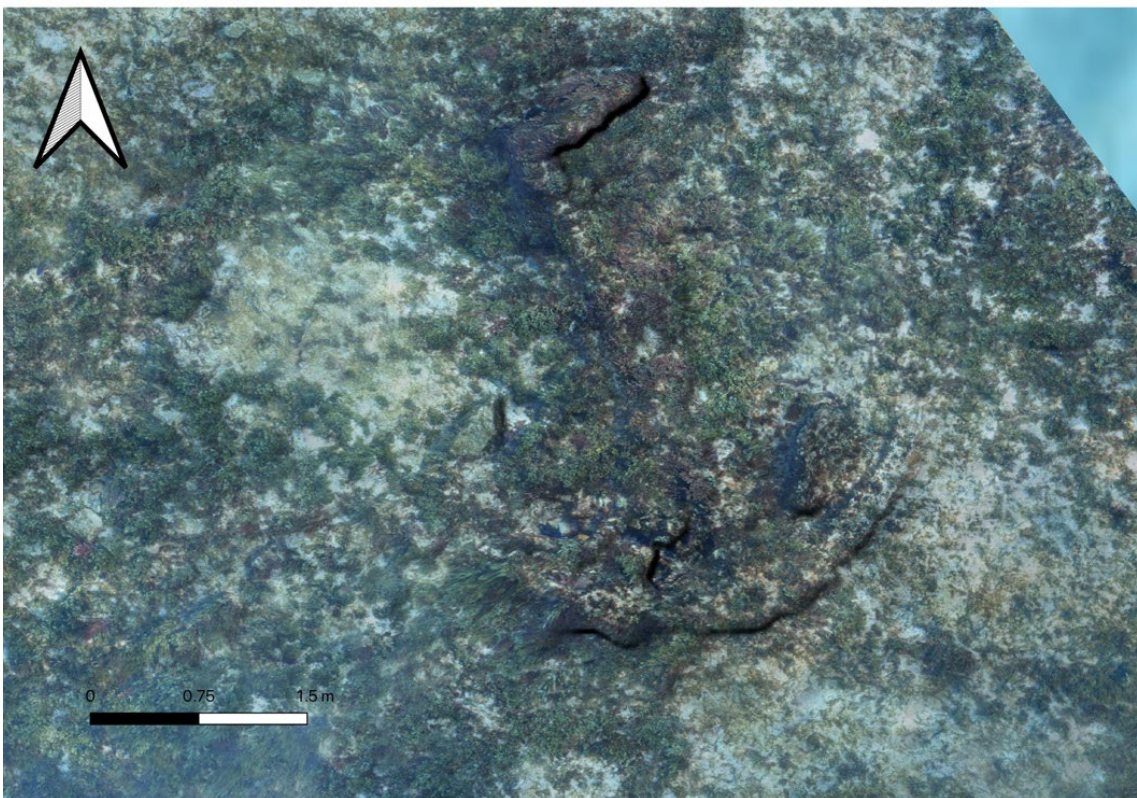
- 9) The 'tangled anchor' that had been variously drawn on site plans as a single anchor, or two anchors, was confirmed to be only a single anchor.
- 10) The anchor with buried crown in outside reef gutter area was observed to have a fluke/palm next to it.

Fig. 26. Orthophoto from 3D model of 'tangled anchor' east of 12-cannon area, confirming it is a single anchor, and not two anchors (P. Morrison, WA Museum, 2022).

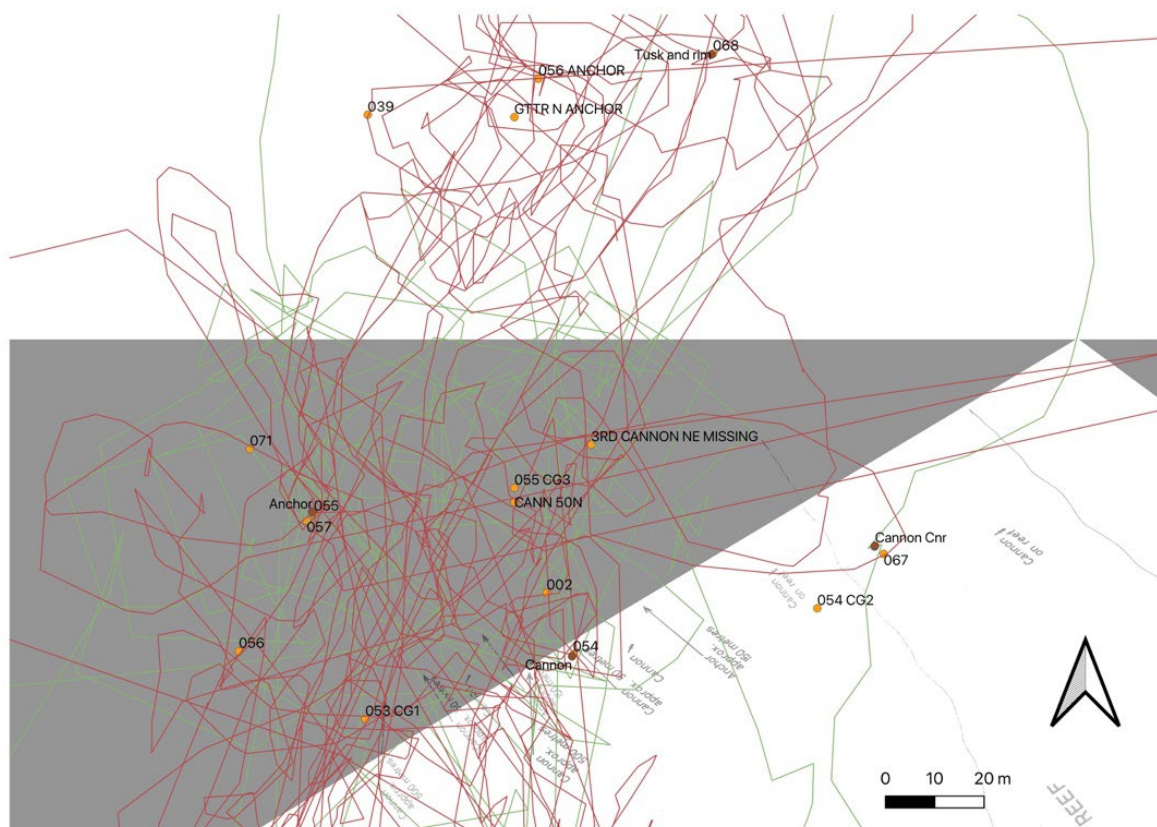
Fig. 30. Vessel and jetski GPS tracks showing comprehensive survey coverage in area of missing north-east cannon—'3RD CANNON NE MISSING' point indicates search position obtained from georeferenced 1978 site plan (R. Anderson, WA Museum, 2022).
